This map is preliminary and has not been reviewed for conformity with U.S. Geological Survey standards and nomenclature.

SATICOY, CALIF.
SW/4 SANTA PAULA 15' QUADRANGLE
N3415-W11907.5/7.5

SHEET 3 OF 4

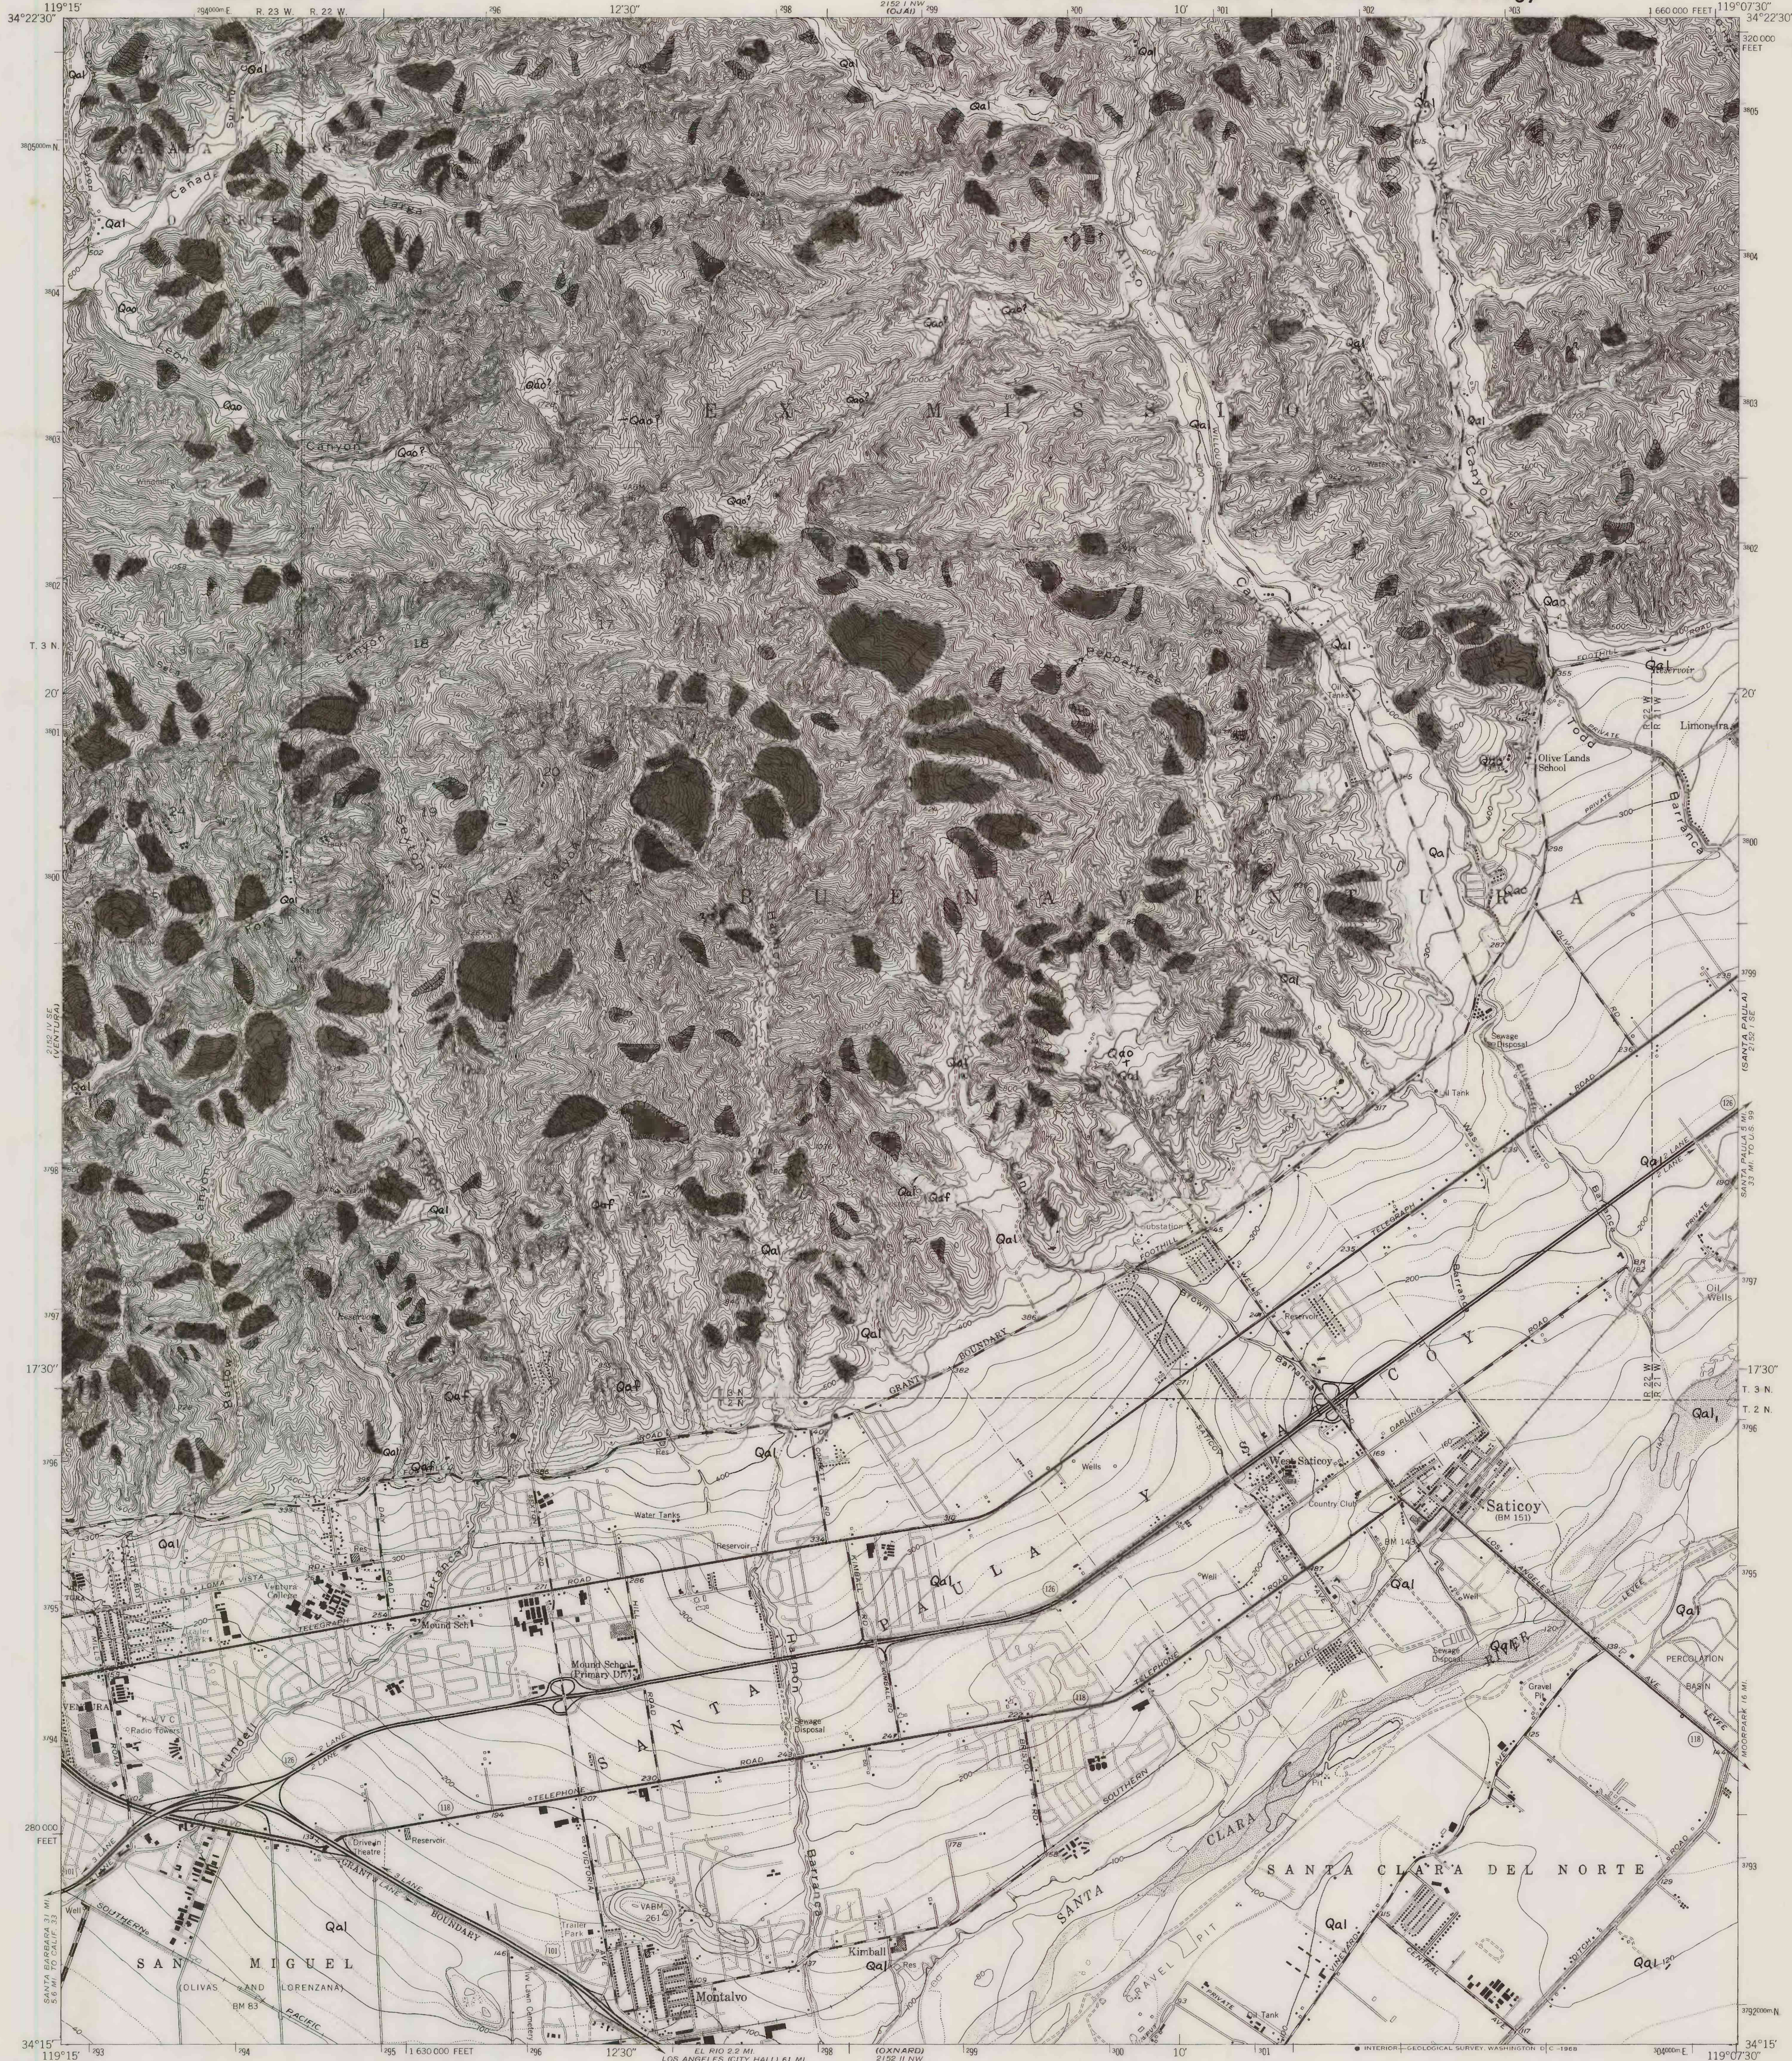
The accompanying map gives an inventory of the 1969 soil-slip scars and debris-flow channels and deposits in part of the Santa Clara River valley area. The map was prepared by interpretation of morphological features visible on high-quality black-and-white stereoscopic aerial photographs taken in August 1967 and July 1969 (scale 1:32,000). Only those features visible on the photographs were used in the determination of the nature and extent of the surficial units; only brief, widely scattered field checks were made.

The map does not distinguish between areas of soil-slip scars, routes of subsequent debris flows, or areas of debris-flow deposition—all are included together. Most of the distinguishable debris-flow scars and deposits were confined to first- through third-order stream basins (Strahler, 1952), although some of the distinguishable largest flows are in higher order basins. Most of the material transported by debris flows will eventually be transported onto major valley floors by fluvial flow.

Some large composite landslides, measured in square miles of areal extent, are difficult to recognize simply because they are so large. Such large landslides commonly contain obvious small satellite landslides that tend to attract attention away from the larger landslide. Landslides smaller than about 300 ft in maximum dimension were difficult to see on the photographs; those suspected of being landslides are marked by a query and are not bounded by contact lines. Areas with morphological features suggestive of but not definitely known to be landslides are queried. Some landslides too narrow to be shown accurately at the scale of this map are indicated by a single arrow. Within large landslides, internal satellite landslides and scarps are shown where they could be identified. Bedrock is not labeled.

Recognition and accuracy of delineation of the surficial deposits depends on: (1) age—the younger the feature, the more visible its morphology; (2) extent of areas concealed by deep shadow; (3) sun angle at time of photography; (4) height and density of vegetation; and (5) degree to which man has modified the landscape. Generally, the younger landslides have clearer, more distinctive landslide morphology. With increasing age a landslide is progressively modified and tends to blend with the normal morphology of the surrounding landscape; consequently the viewer's ability to recognize and delineate the landslide is diminished. Recognition based on surface features ceases completely with full integration of the landslide into the landscape. Field observations also commonly fail to detect landslides largely or entirely integrated into the landscape. Such eroded landslides generally are recognized only in artificial exposures such as those produced by hillside grading operations.

Readily visible features of many landslides are the scarp and crown line. Distal and lower lateral limits are commonly difficult to identify on aerial photographs because: (1) erosion has modified or removed the distal parts; (2) vegetation or shadow obscures the topographically low areas; or (3) the toe and lower lateral margins never formed distinctive morphology (some "incipient" landslides have well-defined scarps but did not develop distal parts).
